Manhole Inspection Summary

Manhole # S19I1_018MH

Insp Date: **4/18/08 9:54 AM**

Location Address: **2626 janice av**

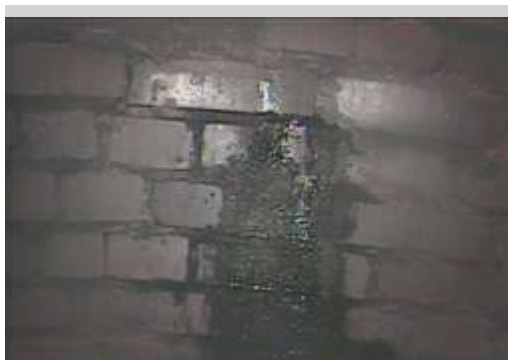
Defect 4

Infiltration: ☐ None ☐ Joint ☐ Cracks ☐ Mortar ☐ Roots ☒ **Wall**

infiltration @ barrel wall

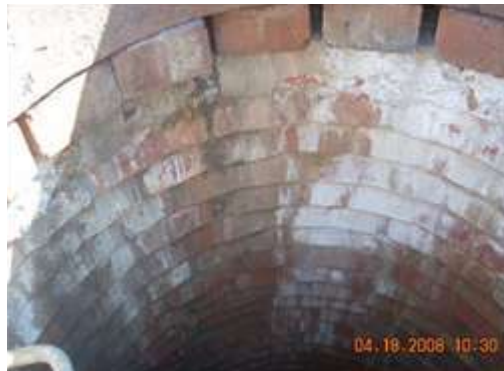
Defect 3

Infiltration: ☐ None ☒ **Joint** ☐ Cracks ☐ Mortar ☐ Roots ☐ Wall

infiltration @ chimney joint

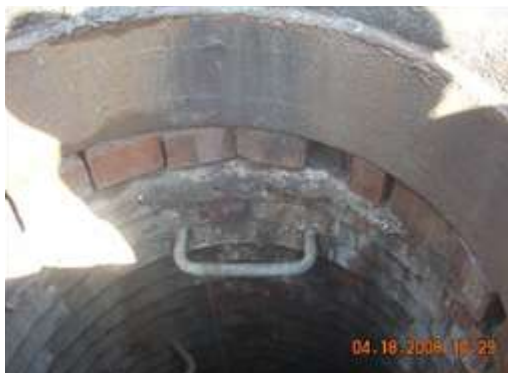
Defect 2

Frame Offset: **0** (in.) Condition: ☐ Sound ☐ Cracked ☒ **Leaks**

inflow evidence (frame leaks)

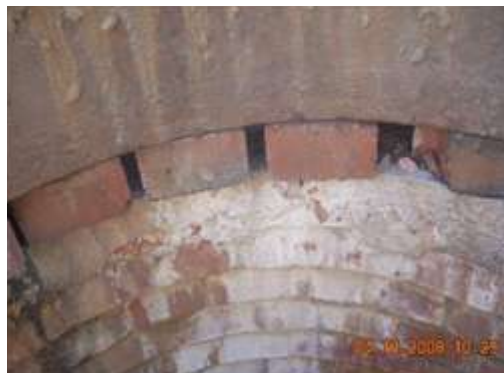
Defect 1

Condition: ☐ Sound ☐ Cracked ☐ Root Intrusion ☒ **Loose Brick** ☐ Deteriorated

loose chimney bricks
